THE OLD HOME PLACE:

AN ARCHAEOLOGICAL AND HISTORICAL
INVESTIGATION OF FIVE FARM SITES
ALONG THE SAVANNAH RIVER,
GEORGIA AND SOUTH CAROLINA

THE OLD HOME PLACE:
AN ARCHAEOLOGICAL AND HISTORICAL
INVESTIGATION OF FIVE FARM SITES
ALONG THE SAVANNAH RIVER,
GEORGIA AND SOUTH CAROLINA

Division of Archeological Services
National Park Service, Southeast Region
Atlanta, Georgia 30303
Contract Number CX-5000-1-4062

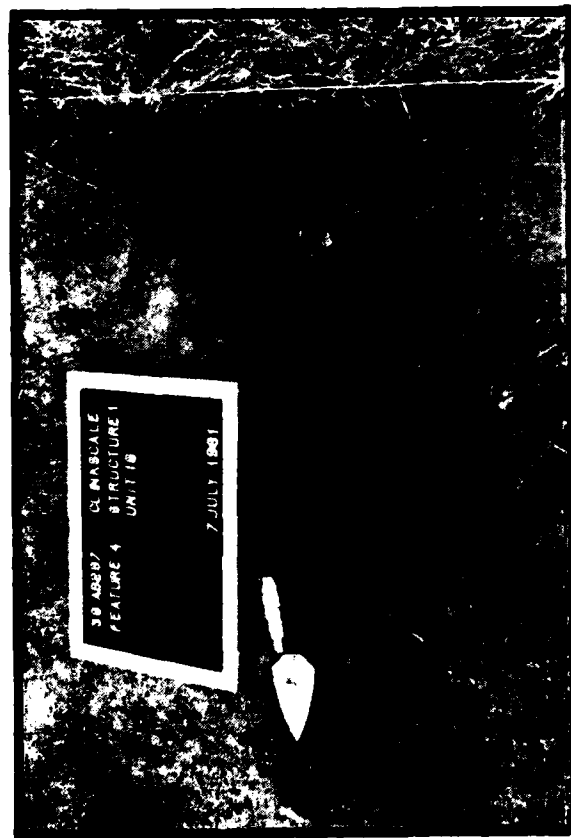
PLATE 3.

Upper Left: Clinkscapes Site (38AB287), Test Unit 16, Feature 4, Possible Flower Bed.

The house itself, and the excavations that were undertaken within its perimeter, are discussed in detail in Chapter VII. One 5' x 5' test unit (T.U. 16) was placed in the front yard of the house site, however, to determine the extent and nature of possible yard scatter. The soil in this unit consisted of one layer of dark brown (10YR3/6) sandy clay above the red (2.5YR4/8) clay subsoil. Artifacts recovered from this level were primarily window glass, nails, and quartz flakes, with some additional ceramic and metal objects. Two features (Features 3 and 4) were noted at the interface of Level 1 and the subsoil. Feature 3 included three pieces of worked quartz and some burned timbers, possibly indicating a prehistoric origin. The prehistoric component at the Clinkscapes site is discussed in detail in Appendix A. Feature 4 was a shallow rectangular depression, approximately two feet long and one foot wide, that extended out of the south wall of Unit 16 (Plate 3, upper

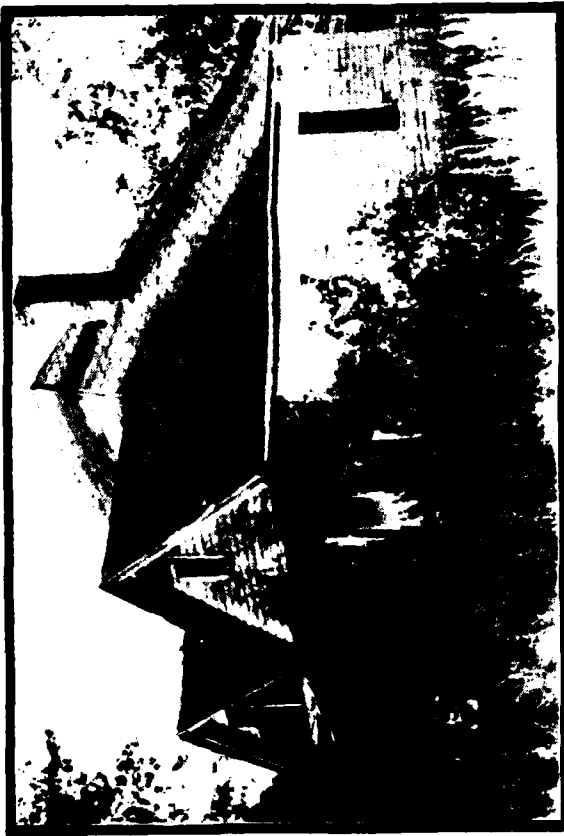
PLATE 6.

Upper Left: James White House, an Extant Example of a "Roundtop."

Measurements of the White house were taken as a comparison to the remains of the Gilbert Gray house. The White house was found to measure approximately 43 feet by 49 feet, and the stone bases of the interior chimneys are located about 25 feet apart, center to center. However, the two large piles of building rubble that are presumed to be the remains of the chimneys at Gilbert Gray's house are located 55 feet apart. Even if the Gray house was somewhat larger than the White sisters' house, it surely was not so large as to have interior chimneys spaced so far apart. Also, when an on-site inspection was made by the Bullards, they both agreed that the two chimney falls were not in their correct locations. Thus, it appears that the piles of rubble from the house have been moved since its destruction, probably during the previously discussed logging operations (Plate 6, upper right).

No intact foundation piers were noted at the Gray house site, although several stones were found randomly scattered across the site. Stones were probably used for the construction of the piers, but the possibility exists that red cedar logs or stumps may also have been employed. Cedar pilings are present at the Bullards' house, and a combination of stone and cedar pilings was found at the White house (Plate 6, lower left).

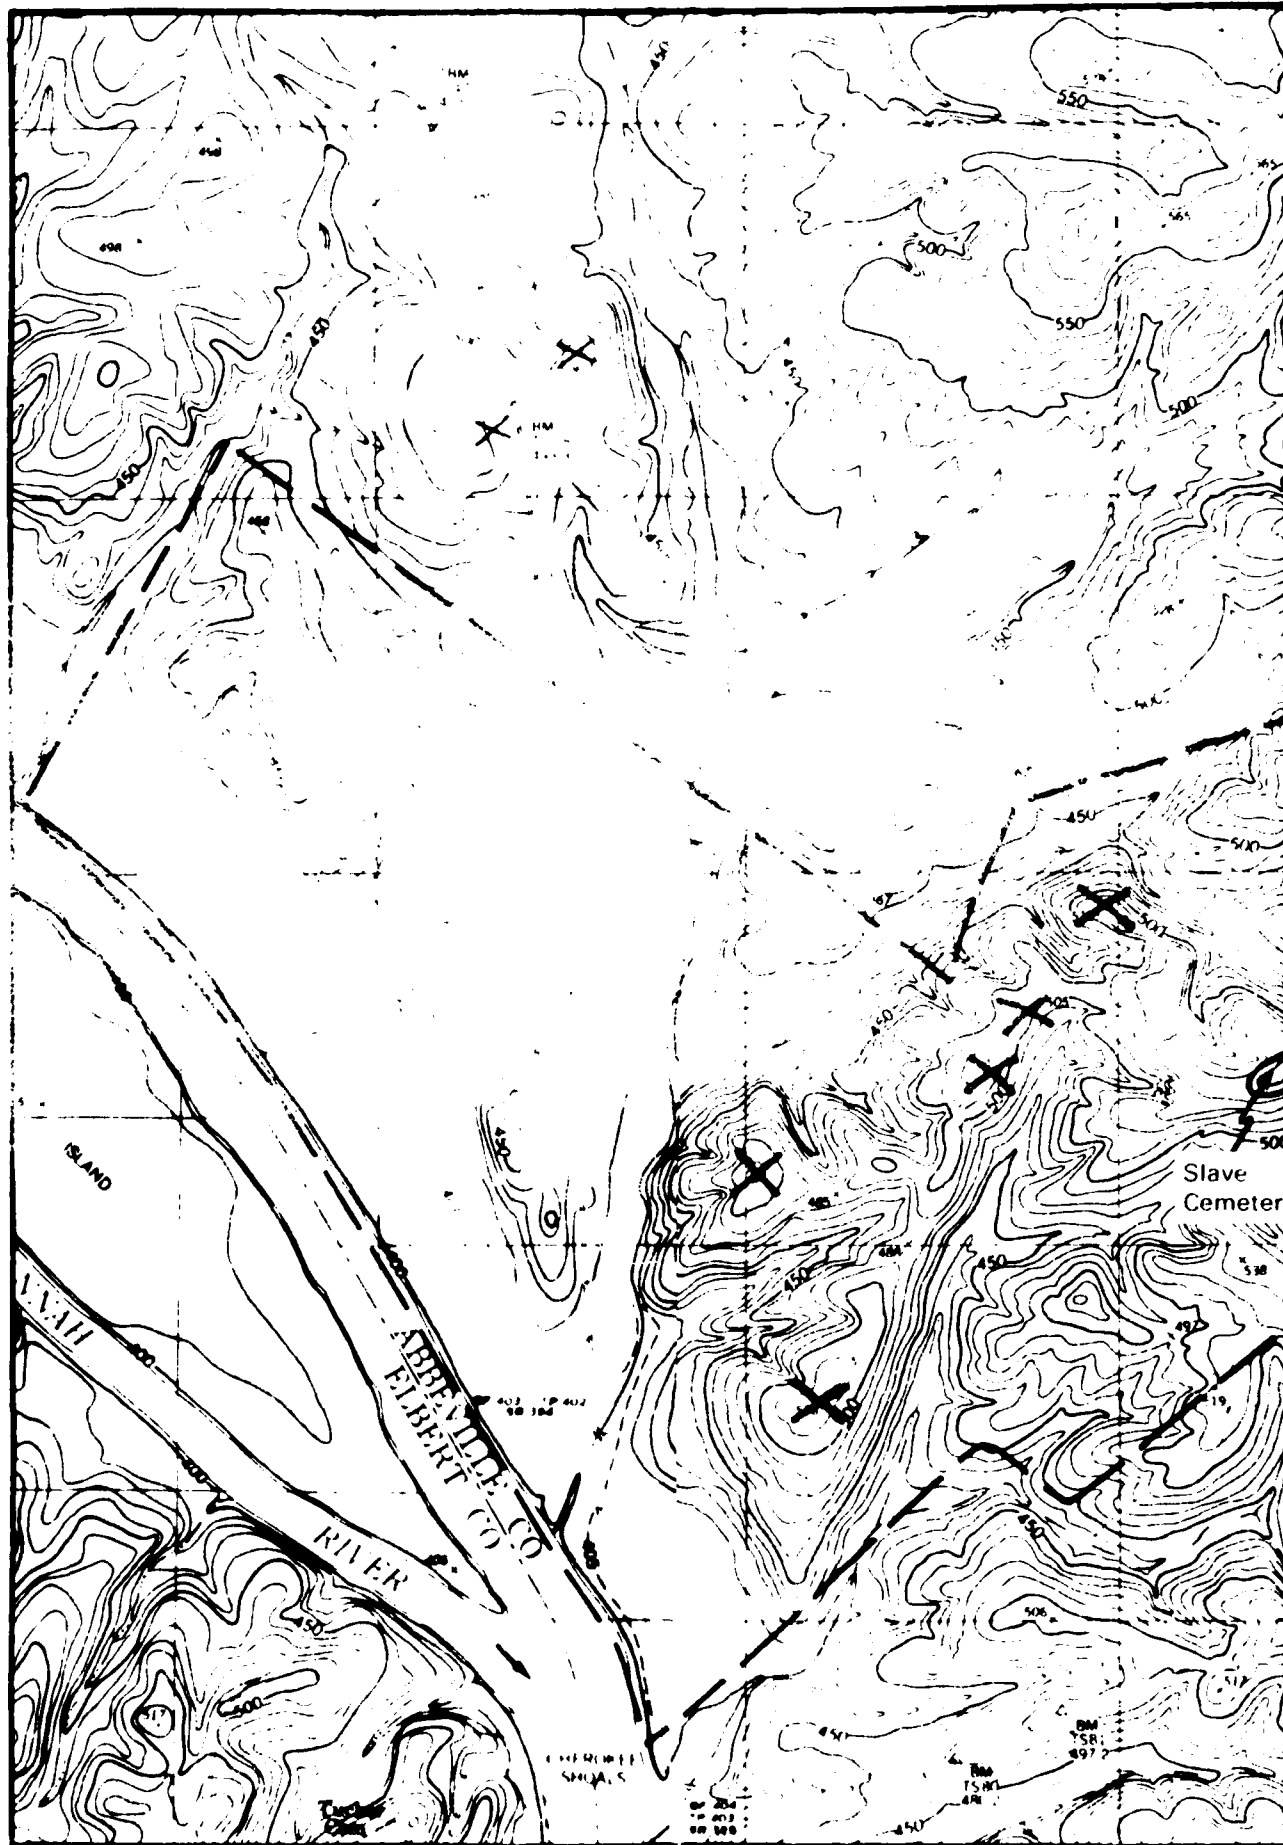
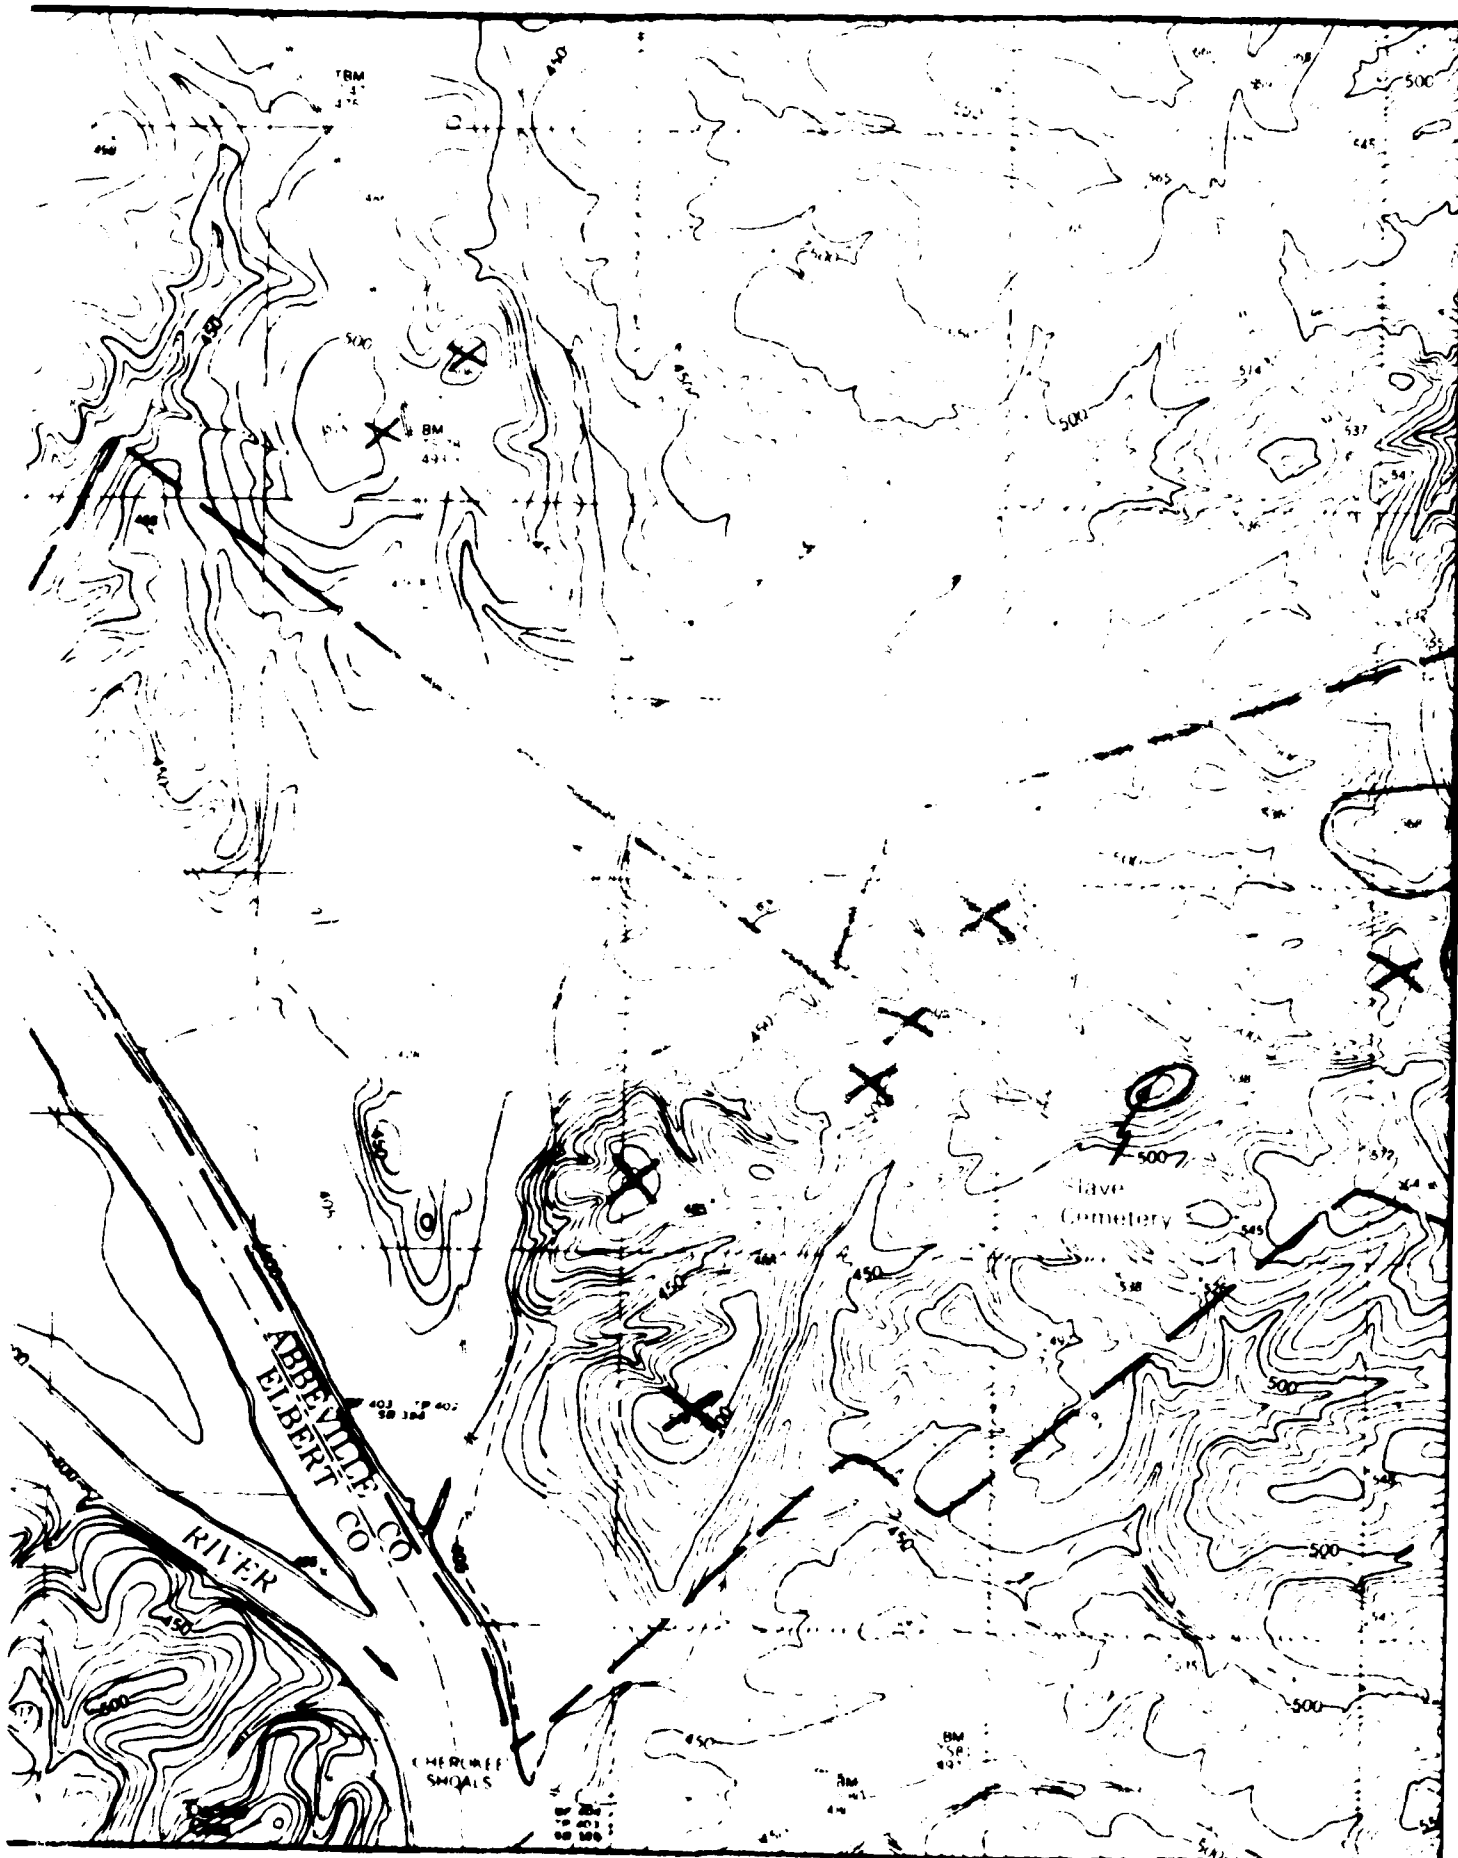
FIGURE 27

**TOPOGRAPHIC MAP OF THE McALLA I SITE (38AB78)
AND PORTIONS OF OTHER McALLA LANDS (BASED ON 1834
STATE PLAT)**

It is known with certainty, however, that John McCalla initially purchased 768 acres in 1833. The approximate boundaries of this tract are known and have been shown on Figure 27. This acreage will be considered the core of the McCalla I site. John McCalla probably continued to add acreage to his farm, although there are no records to confirm this assumption, and his son, George, most certainly increased the size of the plantation. By 1860 he owned 3,000 acres of land (U.S. Bureau of Census 1860). However, as a result of Reconstruction, George McCalla was unable to retain possession of all this land, and by the time of his death in 1886, his total acreage was listed at 2,158. This included an unknown amount of acreage (it may have been around 964 acres, if later tax records for John W. McCalla are correct) located directly south of the original plat and known as the Speer place. It probably also included some land north of the original tract.

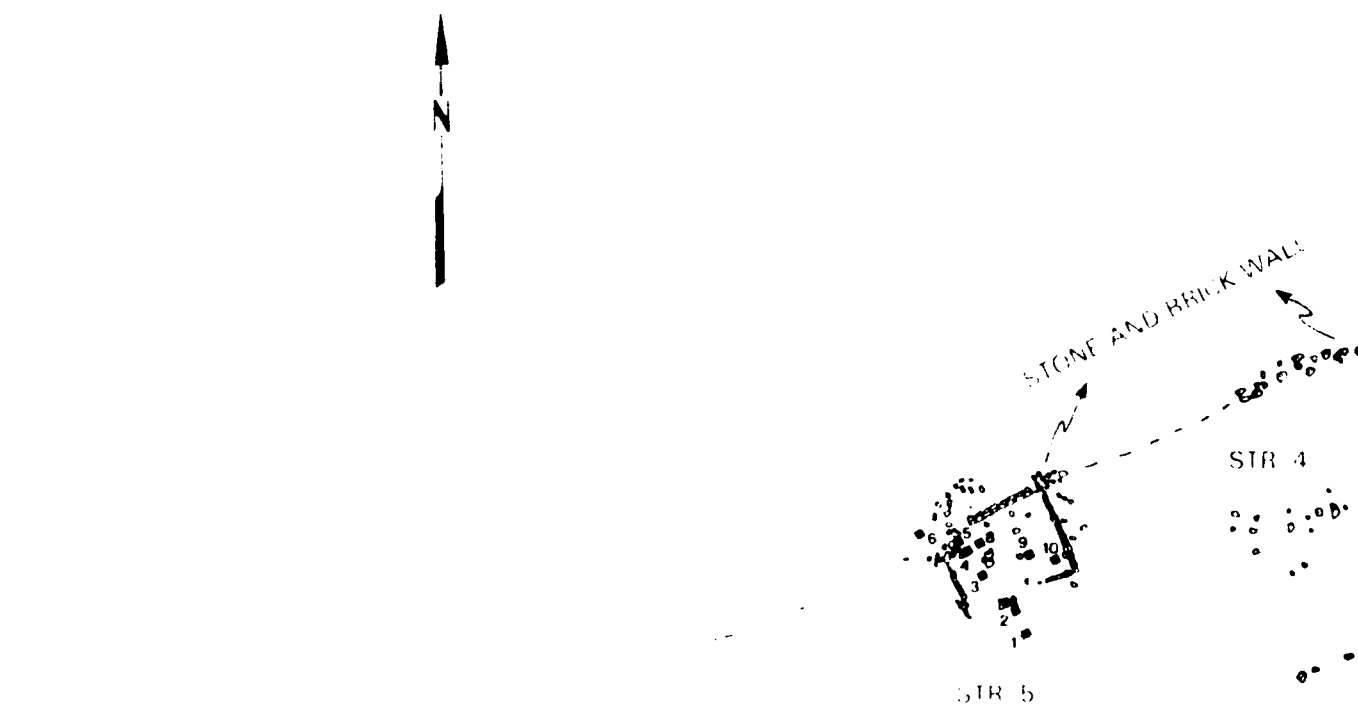
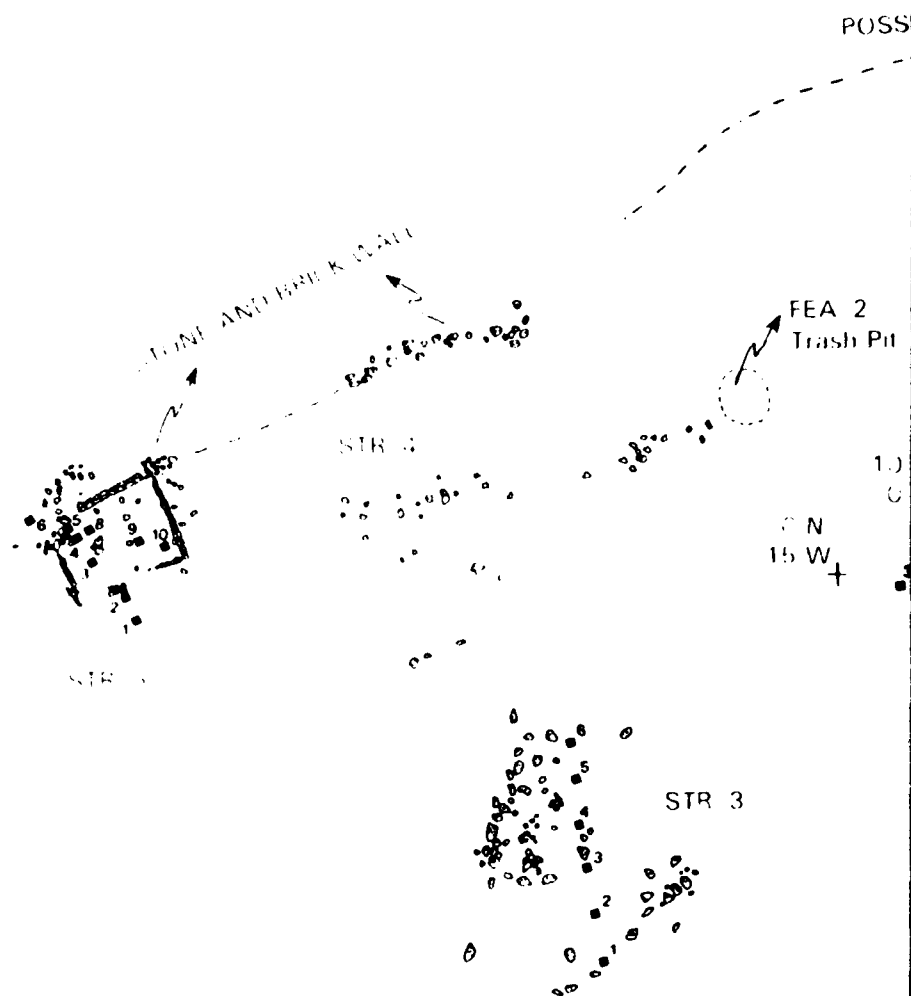
FIGURE 29
McCALLA SITE PLAN (38AB78)
DETAIL OF NORTH HALF OF SITE

Five shovel tests were excavated in and near the probable location of Structure 2 (Figure 29). All of the shovel tests revealed several levels of deposition inside and near the structure. Some of the layers were comprised of mixed clay and mortar, and extended as deep as 1.4 feet below surface. All of the tests contained subsistence-related artifacts, especially ceramics and bottle glass, thereby supporting the interpretation that this structure was indeed a kitchen. In addition, a piece of lead water pipe was found in Shovel Cut 5. Architecturally related material was also recovered from all of the shovel tests. Most of the artifactual material that was collected is non-diagnostic in terms of dating the structure. Much of the material dates anywhere from the Civil War to the first quarter of the twentieth century. However, a wrought nail was found in Shovel Cut 3 and another in Shovel Cut 4, intimating that the construction of Structure 2 was probably contemporaneous with the main house and that both appear to date to the early decades of the nineteenth century. Also recovered from Shovel Cut 4 were several pearlware sherds dating from the first half of the nineteenth century (Plate 8, upper left).

Located approximately 58 feet southwest of the 0 N, 0 E datum, Structure 3 appears to have been a roughly rectangular building, around 35 feet long by 25 feet wide, with its long axis lying in a northwest-to-southeast orientation (Figures 28 and 29). The wall foundations or pier rubble (the building has been subject to some disturbance) are predominantly of stone. After mapping the surface remains of the building, six shovel cuts were placed along the long axis of the structure, at seven-foot intervals. Each shovel test measured approximately two

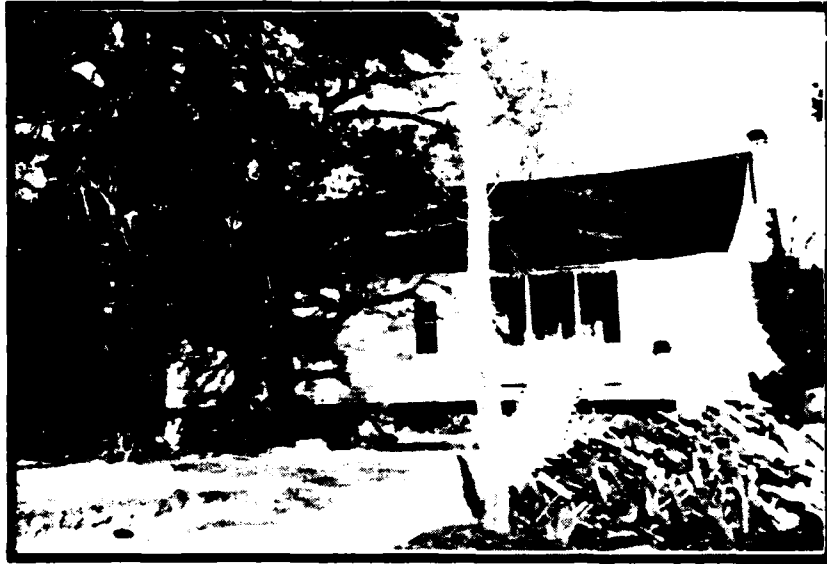
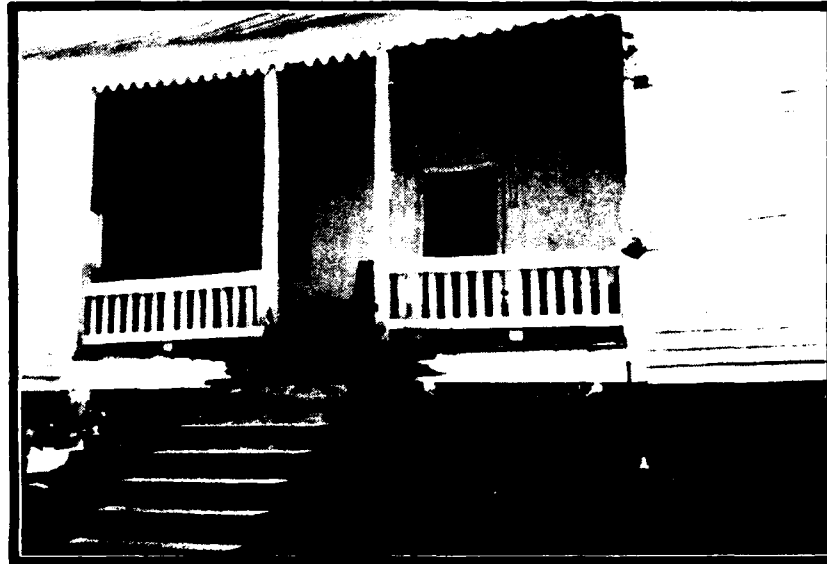
PLATE 14. Top: Harper (38AB21) House, Front View Looking West (Courtesy of the U.S. Army Corps of Engineers, Savannah District). Bottom: Closeup of Back Porch, Harper (38AB21) House (Courtesy of the U.S. Army Corps of Engineers, Savannah District).
